ASSESSMENT OF REPAIRED DIAGNOSTIC ULTRASOUND PROBES

NICHOLAS J. DUDLEY^{*,†} and DARREN J WOOLLEY[†]

* Radiation Protection & Radiology Physics, United Lincolnshire Hospitals NHS Trust, Greetwell Road, Lincoln, United Kingdom; and † Multi-Medix, Unit 56 Hayhill Industrial Estate, Barrow upon Soar, Leicestershire, United Kingdom

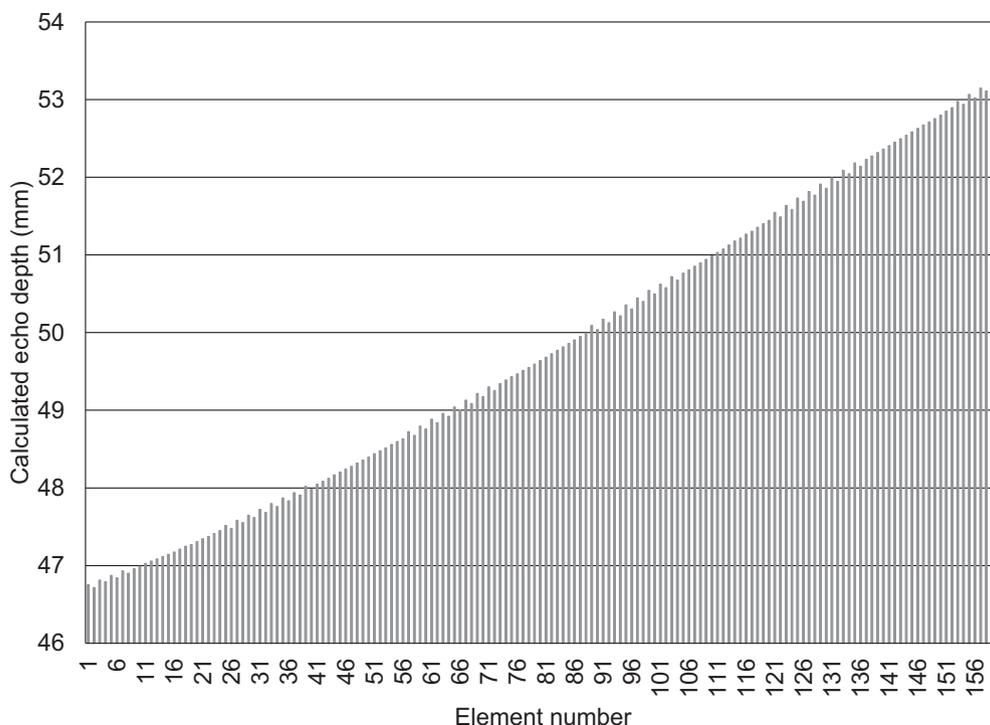
Figure 3 illustrates array sequencing data for an incorrectly re-terminated probe (Toshiba PVT-375 BT, Toshiba Medical Systems, Tokyo, Japan); the supplier (not Toshiba) had stated that this probe had been tested and was fit for use. There are discontinuities in the gradient, indicating that elements had been incorrectly wired with odd and even connections transposed in six areas. Figure 4 illustrates the consequential misregistration of superficial targets in a test object.

Fig. 3. Array sequencing revealing discontinuities in the progression of echo time-of-flight along the array (Toshiba PVT-375 BT, Toshiba Medical Systems, Tokyo, Japan).

order. This may be qualitatively assessed by imaging and looking for misregistration of targets, but this requires operator skill and experience. The array sequencing test, with the probe tilted relative to the reflector in the direction of its long axis, provides an objective assessment; there should be no discontinuities in the echo time of flight gradient. This test is outside the capabilities of most hospitals or clinics and should be performed by the repairer or repair vendor, either as validation of their technique or as confirmation of the efficacy of repair.

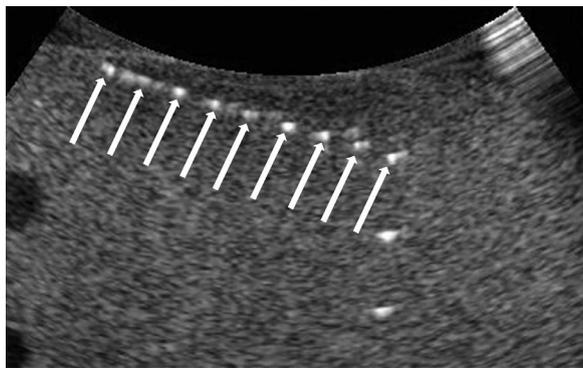
Fig. 4. Misregistration (true targets *arrowed*) caused by incorrect array sequencing (Toshiba PVT-375 BT, Toshiba Medical Systems, Tokyo, Japan).

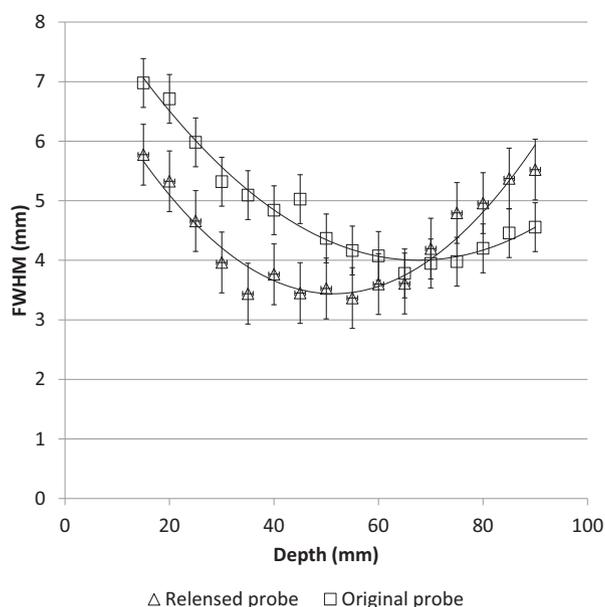
Figure 5 illustrates the effect on slice thickness of an improper third-party lens repair (GE M5 S, GE

Healthcare, Hatfield, UK). The slice focus is in a different position compared with that of an original OEM probe. Additionally, the sensitivity of the probe was affected, the penetration depth (the depth at which the speckle signal fell to twice the noise level; Gibson et al. 2001) being 112 ± 6 mm for the re-lensed probe compared with 122 ± 4 mm for an original OEM probe.

Fig. 5. Full width at half-maximum (FWHM) in the slice direction with second-order polynomial fits to illustrate change in focal depth (GE M5 S, GE Healthcare, Hatfield, UK). Error bars represent ± 1 standard deviation.

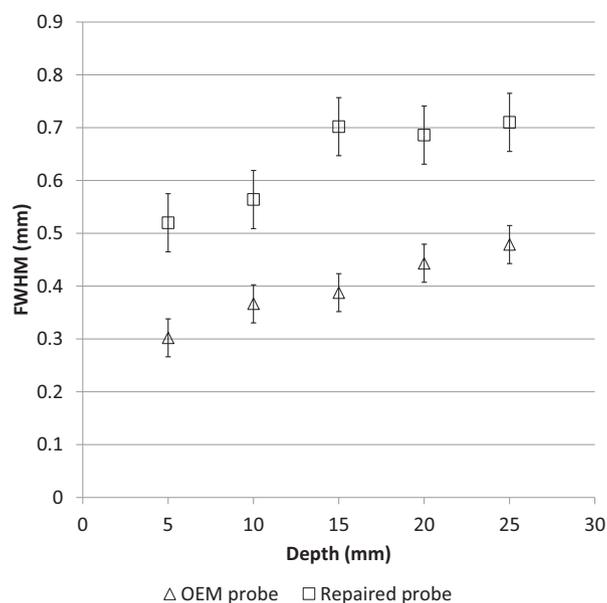
Figure 6 illustrates the lateral resolution of a high-frequency linear array (Philips L12-5, Philips, Amsterdam,

The Netherlands) with a non-OEM acoustic stack and cable, sold as a suitable equivalent to the OEM probe. The resolution is poor compared with that of OEM probes. Figure 7 illustrates the resolution of a repaired transvaginal probe (Philips C10-3 v, Philips, Amsterdam, The Netherlands), where the resolution is again poor compared with that of the OEM probe.

Fig. 6. Lateral full width at half-maximum (FWHM) of nylon target profiles versus target depth for original equipment manufacturer (OEM) and repaired high-frequency linear arrays (Philips L12-5, Philips, Amsterdam, Netherlands). Error bars represent ± 1 standard deviation.

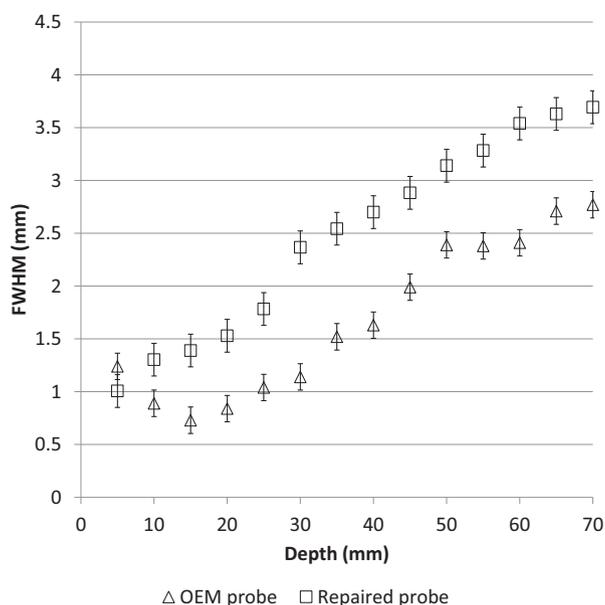
Fig. 7. Lateral full width at half-maximum (FWHM) of nylon target profiles versus target depth for original equipment manufacturer (OEM) and repaired transvaginal probes (Philips C10-3 v, Philips, Amsterdam, Netherlands). Error bars represent ± 1 standard deviation.
