ASSESSMENT OF REPAIRED DIAGNOSTIC ULTRASOUND PROBES

NICHOLAS J. DUDLEY^{*,†} and DARREN J WOOLLEY[†]

* Radiation Protection & Radiology Physics, United Lincolnshire Hospitals NHS Trust, Greetwell Road, Lincoln, United Kingdom; and † Multi-Medix, Unit 56 Hayhill Industrial Estate, Barrow upon Soar, Leicestershire, United Kingdom

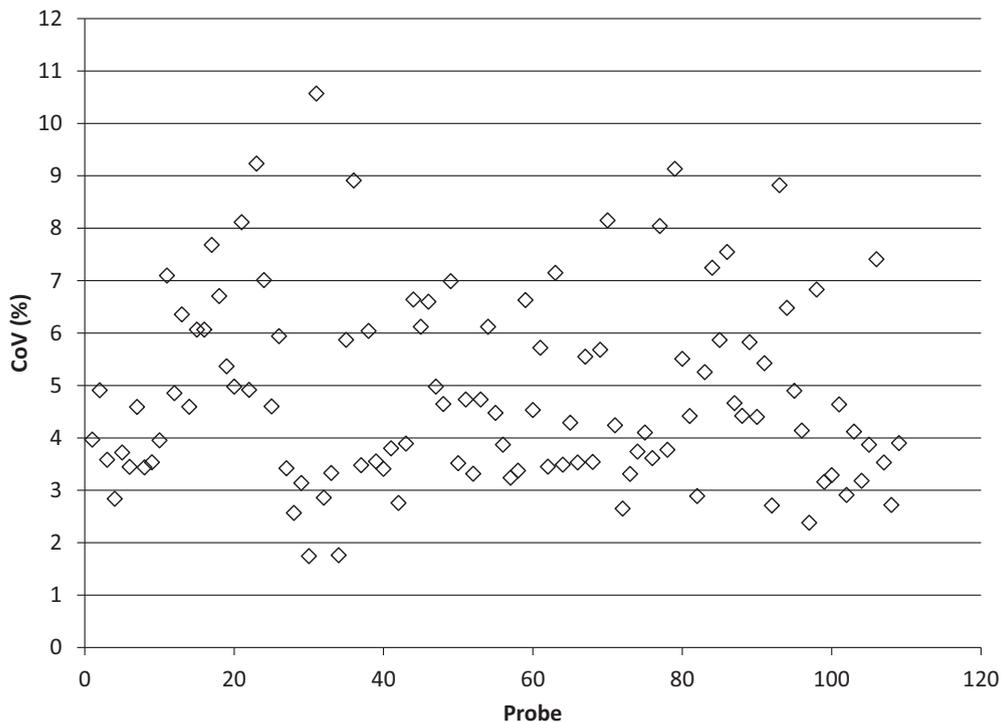
mean sensitivity), no more than two consecutive weak elements and no more than one dead element (<10% of mean sensitivity); *green*, *yellow* and *red* lines are included on the sensitivity graph to represent the 75%, 40% and 10% levels, respectively. There are no widely accepted standards for probe acceptance criteria, and so different testing systems will use different criteria. For example, the authors are aware of a probe repairer using context-specific acceptance criteria, where probes with more than four consecutive weak elements, or an aggregate of three dead elements or two consecutive dead elements would not be repaired and stricter criteria apply for the purchase of new or used probes. It is also possible that testing centres will develop their own criteria; for example, in our practice, we have adopted a coefficient of variation (CoV) limit of 10% for sensitivity based on our own evidence of sensitivity variation illustrated in [Figure 2](#).

Fig. 2. Coefficient of variation of sensitivity for 55 linear arrays and 54 convex arrays. CoV = coefficient of variation.
